SOFT FALL AND PLAYGROUND REQUIREMENTS IN CHILDCARE

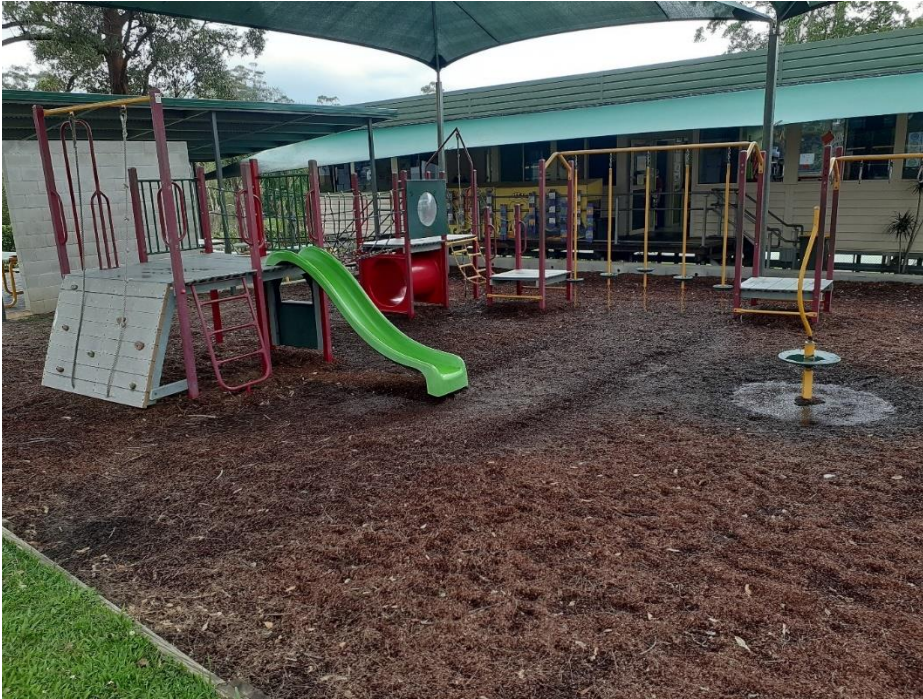
Photo 1 A playground area with bark soft fall. The soft fall material in this playground appears to be too thin to comply with current requirements. If a child were to fall from the playground equipment a possible broken bone or head injury could occur.

Loose materials or 'loose fill' includes materials made up of small particles like sand, woodchip, and mulches. One major benefit to "loose fill" materials is the relatively low cost, however the downside is that maintenance is required in the form of raking, cleaning, and topping up to ensure a consistent depth of at least 300mm or more depending on possible fall heights.

If using in a playground situation make sure to be guided by the Australian Standards for appropriate depth of Loose-fill surfaces (mulch), which is usually to maintain at a minimum depth of 300mm or more depending on possible fall heights.

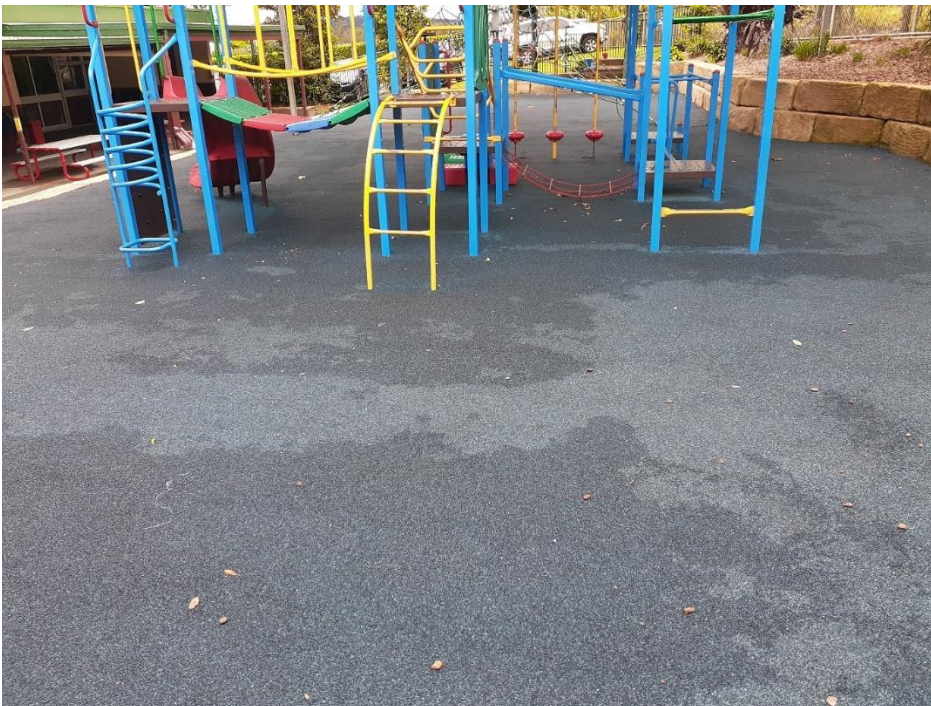
Photo 2 This area has a professionally placed synthetic soft fall ground surface in accordance with Australian Standards set out in AS/NZS 4422: and AS 4685.1.

Solid materials, including rubber matting and wet pour rubber are the other popular choice for Australian playgrounds. These types of rubber surfaces tend to be more expensive but can exceed the lifespan of loose fill material without requiring the same maintenance or upkeep. If installing this sort of material, you should request a certificate of compliance with AS:4422 to ensure adequate impact absorption properties.

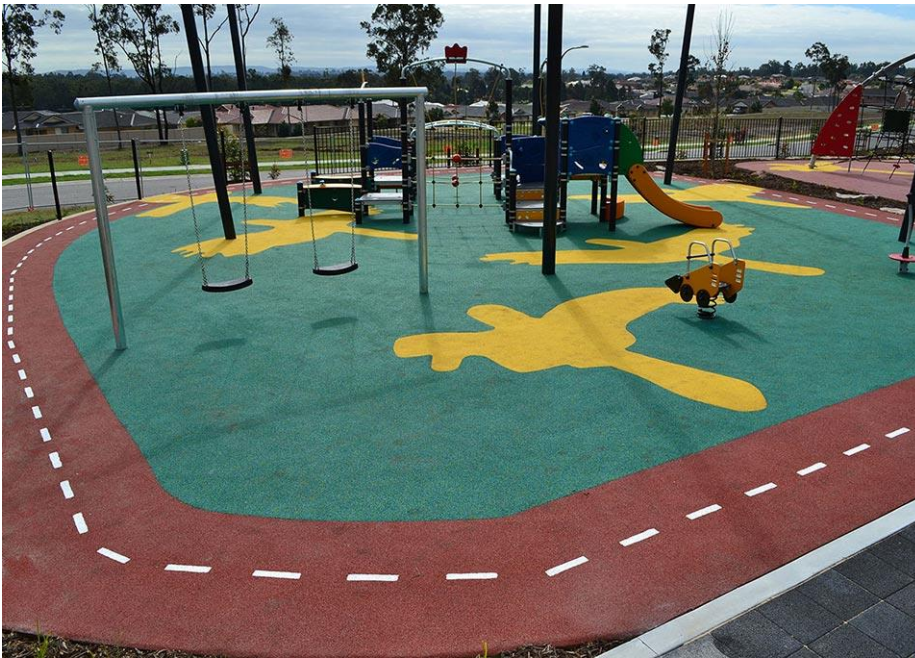
Photo 3 This is an example of a synthetic soft fall. More expensive than sand or bark soft fall, but much longer lasting and easier to maintain. Unlike sand or bark, this surface does not require any raking and is unlikely to lift after wet weather.

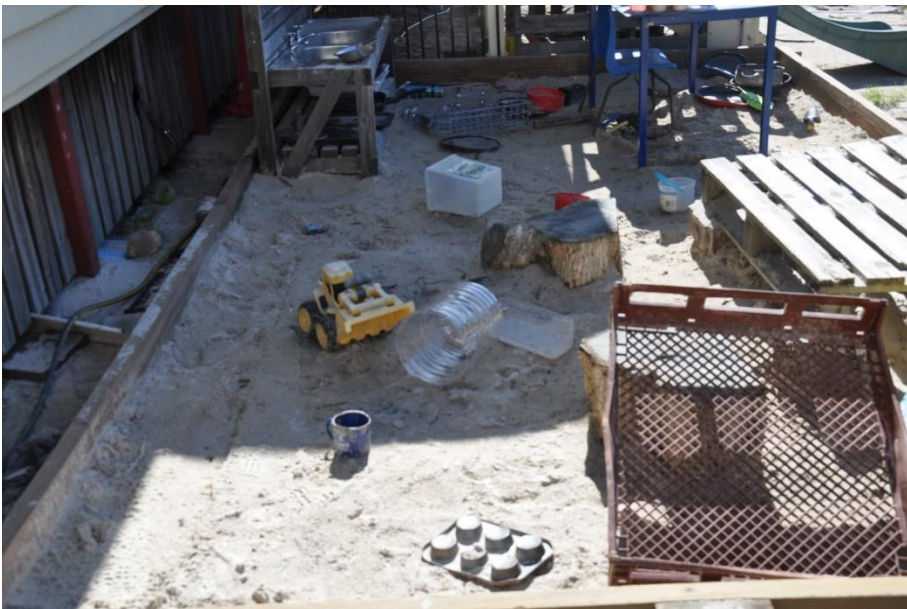
Photo 4 A play area sandpit. All sandpits at childcare centres and schools should be covered at night to prevent nocturnal animals such as possums and feral cats defecating in them. Regular raking and refilling of the sand when required is also recommended as best practice.

Sandpits are often provided in school playgrounds and childcare facilities. The soft sand in the sandpit is also attractive to nocturnal animals such as possums and feral cats. Sandpits should be completely covered at night to prevent nocturnal animals defecating in the sand. Regular raking and refilling of the sandpit, is also recommended.
